CRASH INJURY INVESTIGATION

HU-1A BELL IROQUOIS HELICOPTER ACCIDENT

East St. Louis, Illinois

21 October 1959

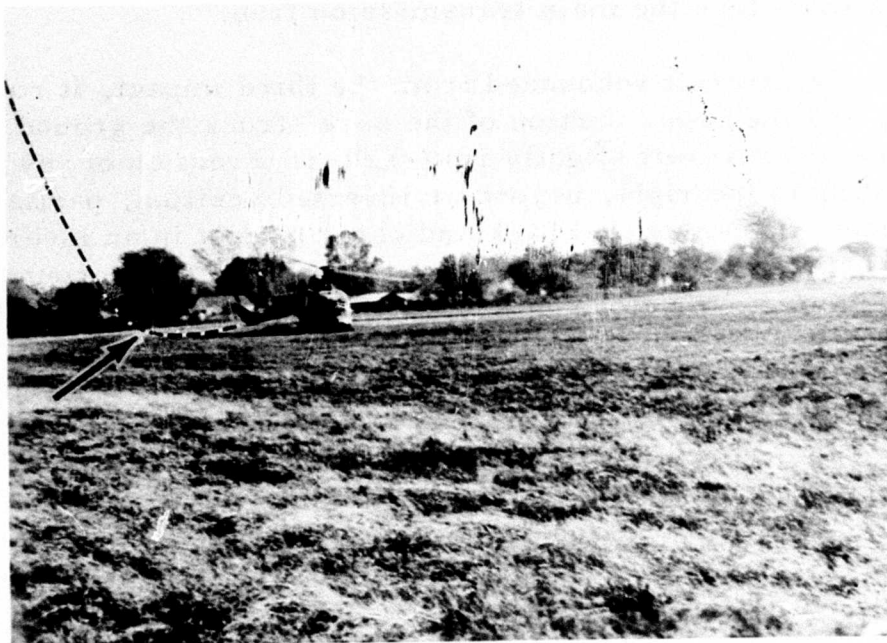
Fig. 3. HU-1A shown rebounding off ground after initial impact. Tail boom is broken downward; fuselage begins turning clockwise. Initial impact gouge indicates aircraft rode on ground at least 12 feet before rebounding back into the air. (Refer to Fig. 8, p. 9).

The tail cone and tail rotor assembly broke free as a unit during the initial impact, and the right side of the tail boom was subjected to a great deal of structural damage. (For action photograph of assembly breaking see Fig. 3, p. 6).

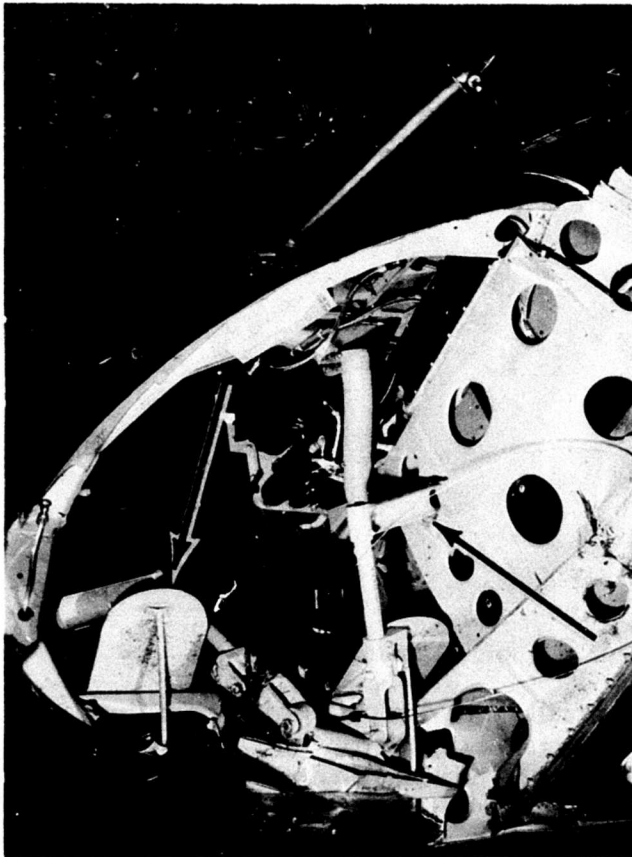
Fig. 33. Right (pilot) pedal well. Pedals (arrows) were broken during gouging.

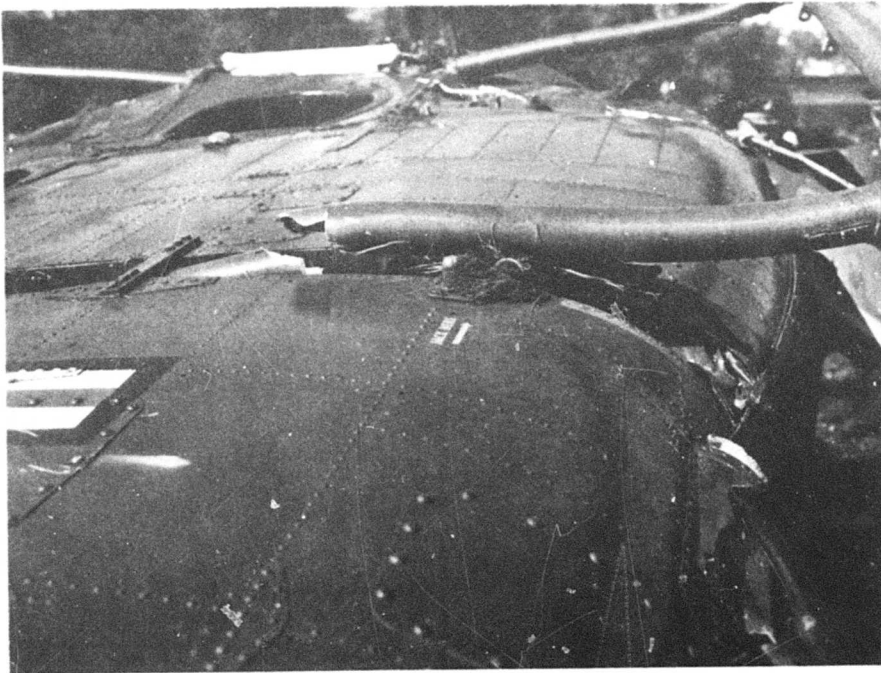
Fig. 44. Close-up of right front cross-tube failure indicates it had deflected to a great extent, absorbing vertical crash force.

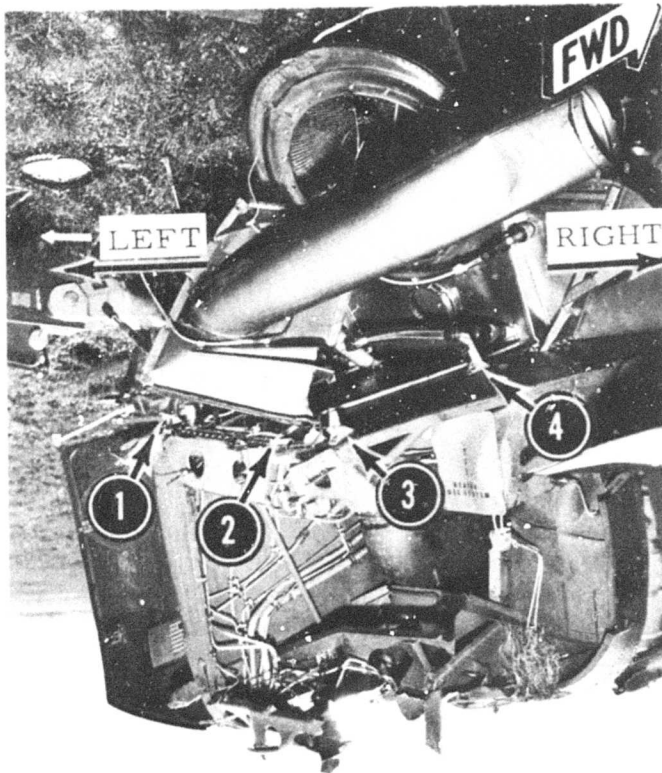
Fig. 46. Forward left (not shown) and aft left (arrow 1) engine mounts failed in compression. Center (arrow 2), aft (arrow 3), and forward (arrow 4) engine mounts failed in tension.

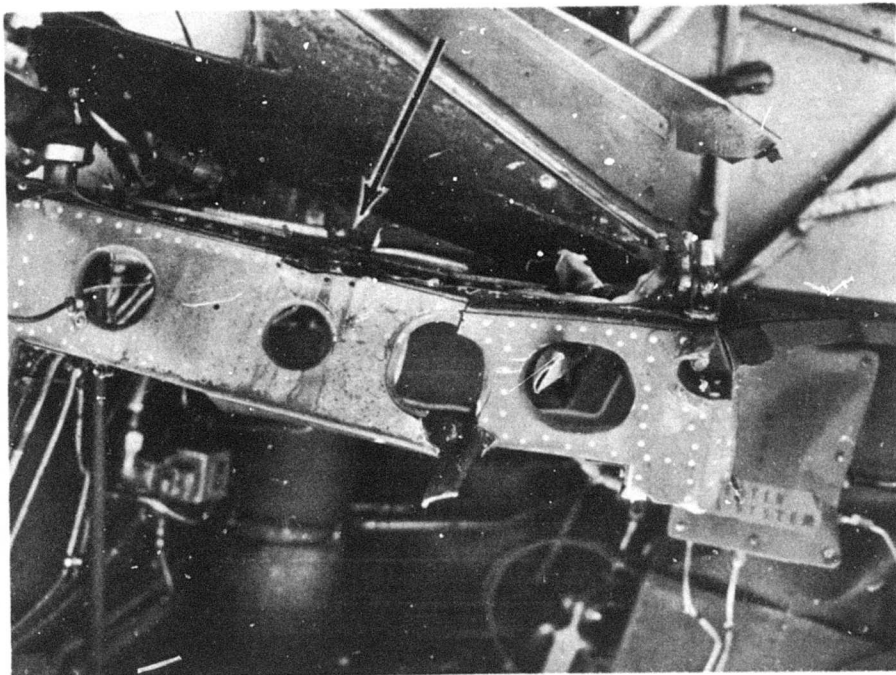
Fig. 47. Center engine mount aft (arrow) was torn free in an upward direction.

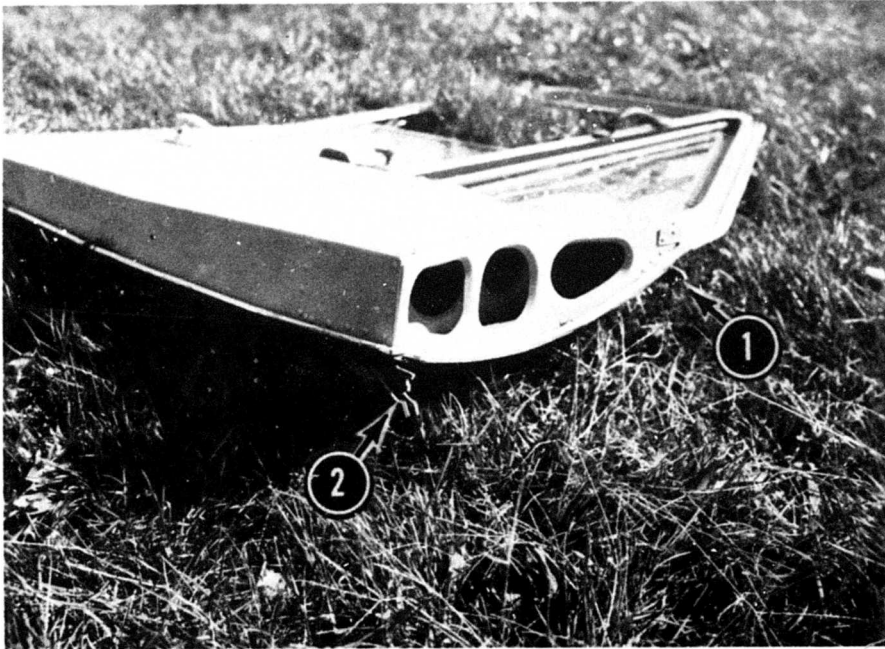
Fig. 50. Left front (copilot's) door, which was also torn partially free at initial impact, was found approximately 175 feet along the crash path. Both the upper (arrow 1) and the lower (arrow 2) hinges were torn free.

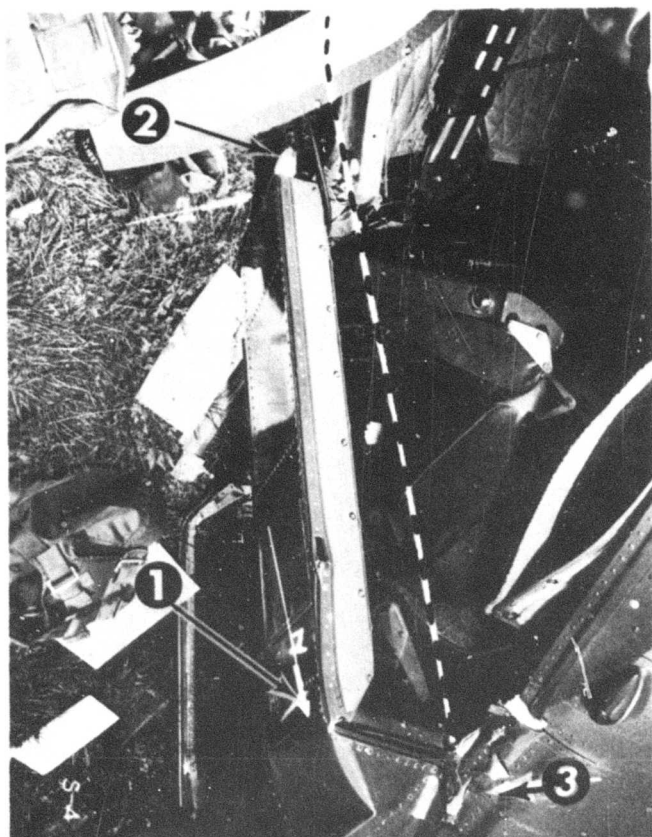
Fig. 68. Left support member, aft edge (looking forward). Note compression buckling (arrow 1). Dotted line indicates normal position. Failure of this member occurred both at the top (arrow 2) and bottom (arrow 3) attachments.

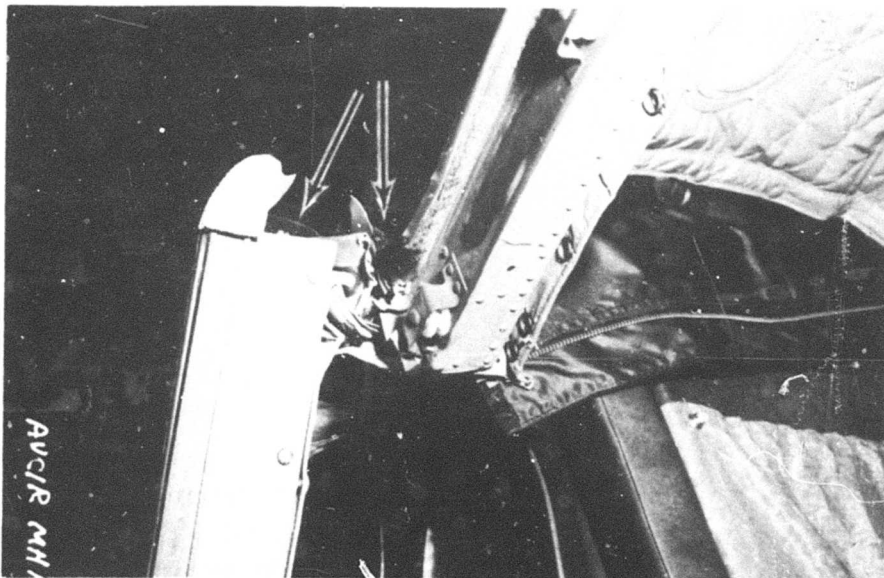
Fig. 69. Left support member, aft edge, top (looking forward). Failure (arrows) is believed to have occurred during final rolling of the fuselage onto its back. Failure of this structure outward, as it occurred, is more desirable than failure inward would be.

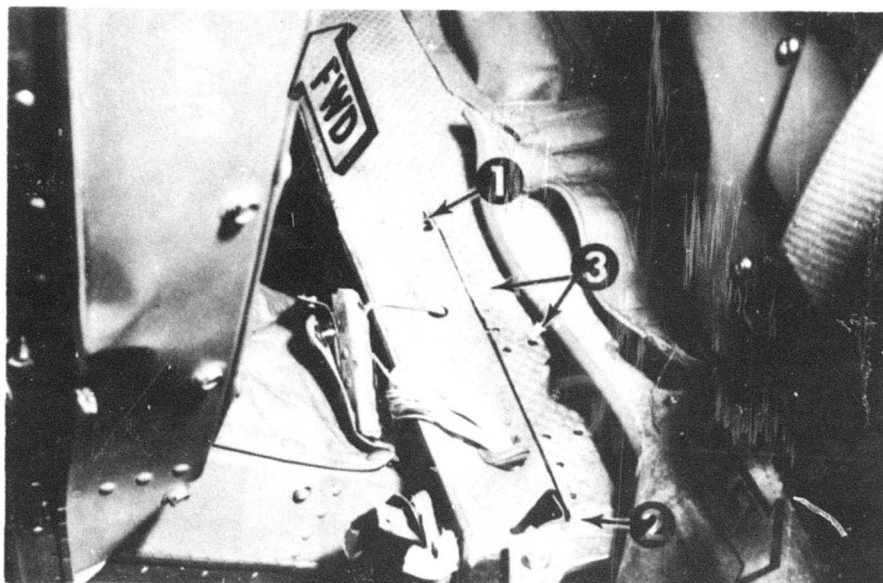
Fig. 70. Left support member, lower attachment points. The triangular cutouts (arrows 1 and 2) allow "L" stringers to pass through vertically. The "L" stringers and the inner and outer skin of the support member attach the member to the fuselage. The line of rivet holes (arrow 3) indicate where the skin attaches to the floor.

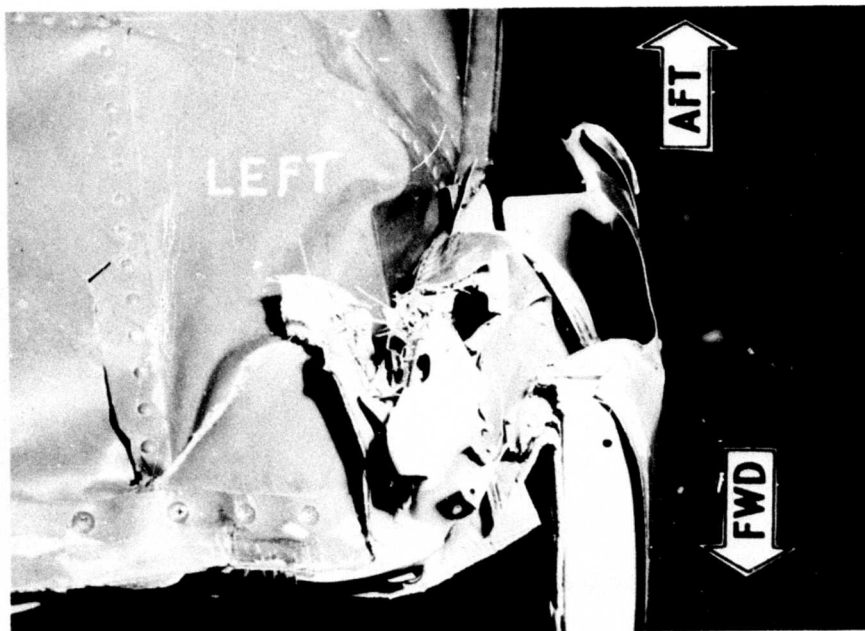
Fig. 72. Left vertical support member, upper attachment point. It does not appear that the "L" stringers extend up to the top of this member for attachment. Inner and outer skin appears to be largely relied upon, in addition to other structural attachment methods, to provide integrity.

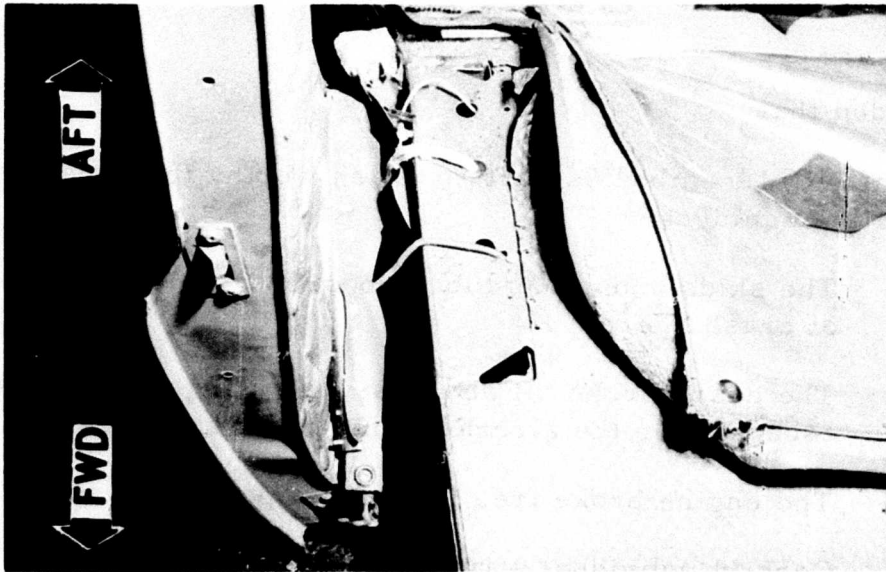
Fig. 73. Right vertical support member, lower attachment point. Failure of this area is essentially the same as the left. Forward and aft "L" stringers and outer skin and inner skin attachments all failed, a condition that allowed the support member to tear free.
